**BOEING AIRPLANE COMPANY**  
**WICHITA, KANSAS**

DOCUMENT NO. WD-14018 DATE January 31, 1956

MODEL BC-47E CONTRACT NO. 5148

TITLE ANALYSIS OF WFT-709 FLIGHT TESTS OF NAVIGATOR'S  
COMPARTMENT DEFROSTING SYSTEM

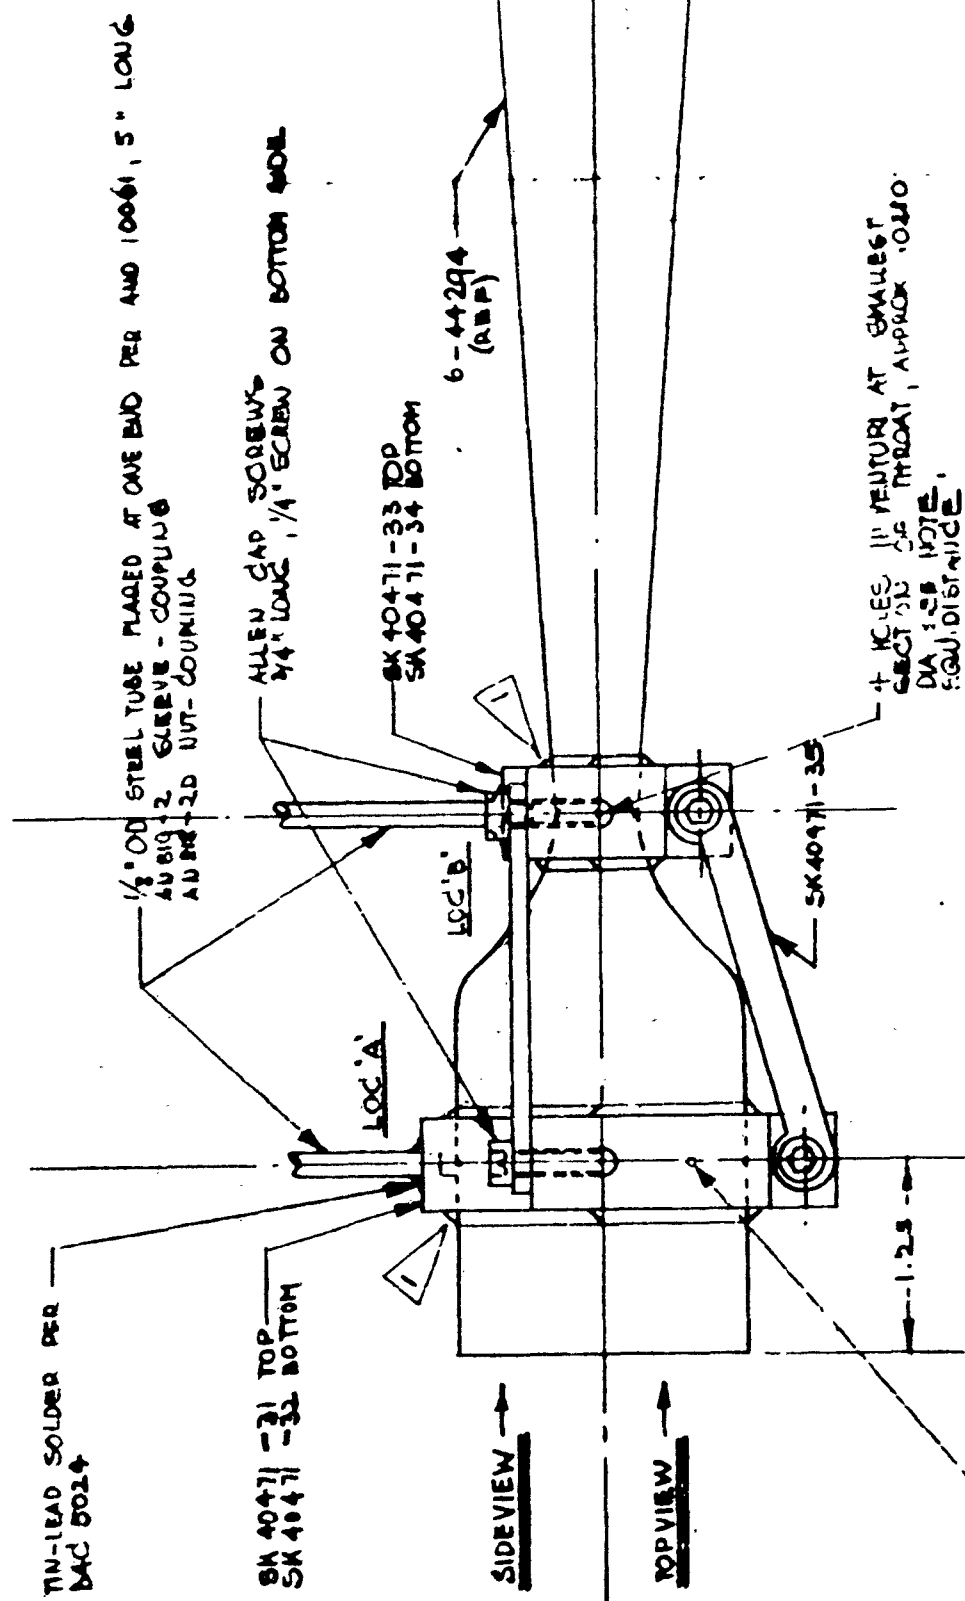
SK-40471-1 ASSY.

8 HOLES IN VENTURI APPROX. 0.280 DIAM EQUIDISTANCE, SEE NOTE

- 1.1.45 Static Pressure Mixed Air Duct to Outside Defrost - Venturi, Location A
- 1.1.46 Static Pressure Mixed Air Duct to Outside Defrost - Venturi, Location B

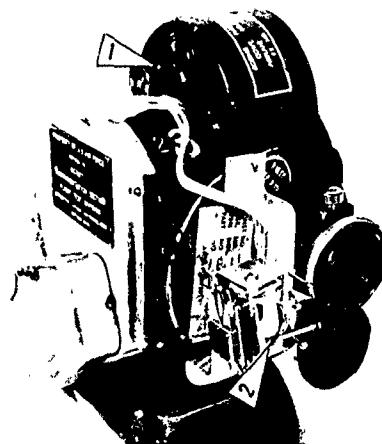
FTW-5593

FILTER ASSY. - A-4 CAMERA

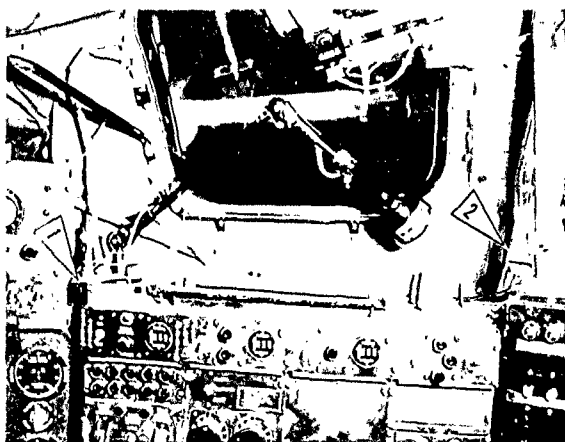
(FPA. 5373)

1 NAV. FACE LEVEL, SK-40337 THERMOCOUPLE -  
ENVIRONMENTAL ATTACH TO STRUCTURE, AT  
APPROX. STA. 115.6 and WL425

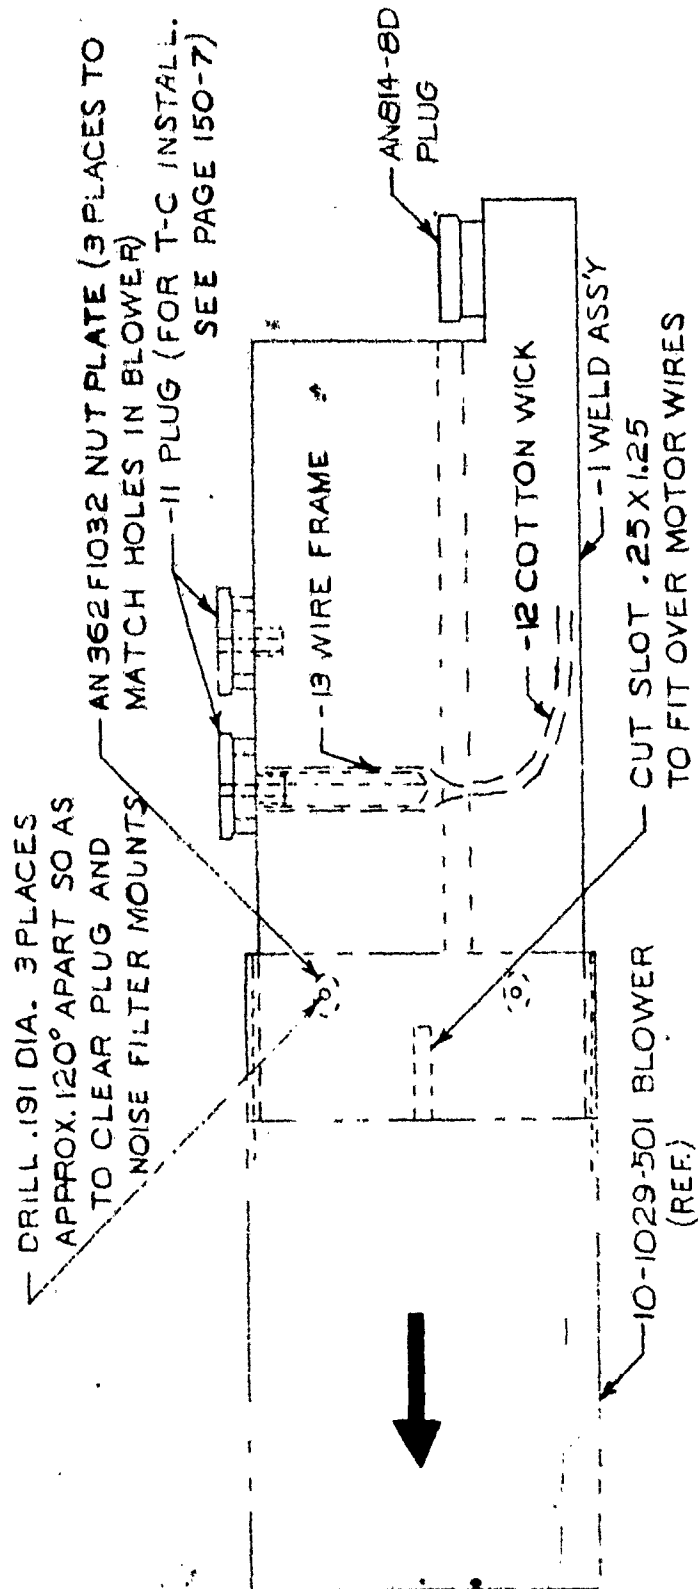
SK-40465-0

ALL	JMc	8/11/53	REVISED	DATE	<b>PICKUP ASSEMBLY</b> <b>WET AND DRY BULB TEMPERATURE</b> <b>BOEING AIRPLANE CO.</b> <small>WICHITA DIVISION WICHITA 1, KANSAS</small>	GEN.
CHECK	<i>[Signature]</i>	8/11/53				WD
APP	<i>[Signature]</i>	9/11/53				12829
APP						150-2
CONTRACT NO.					Insert No. 3 WD-14018 Page 165

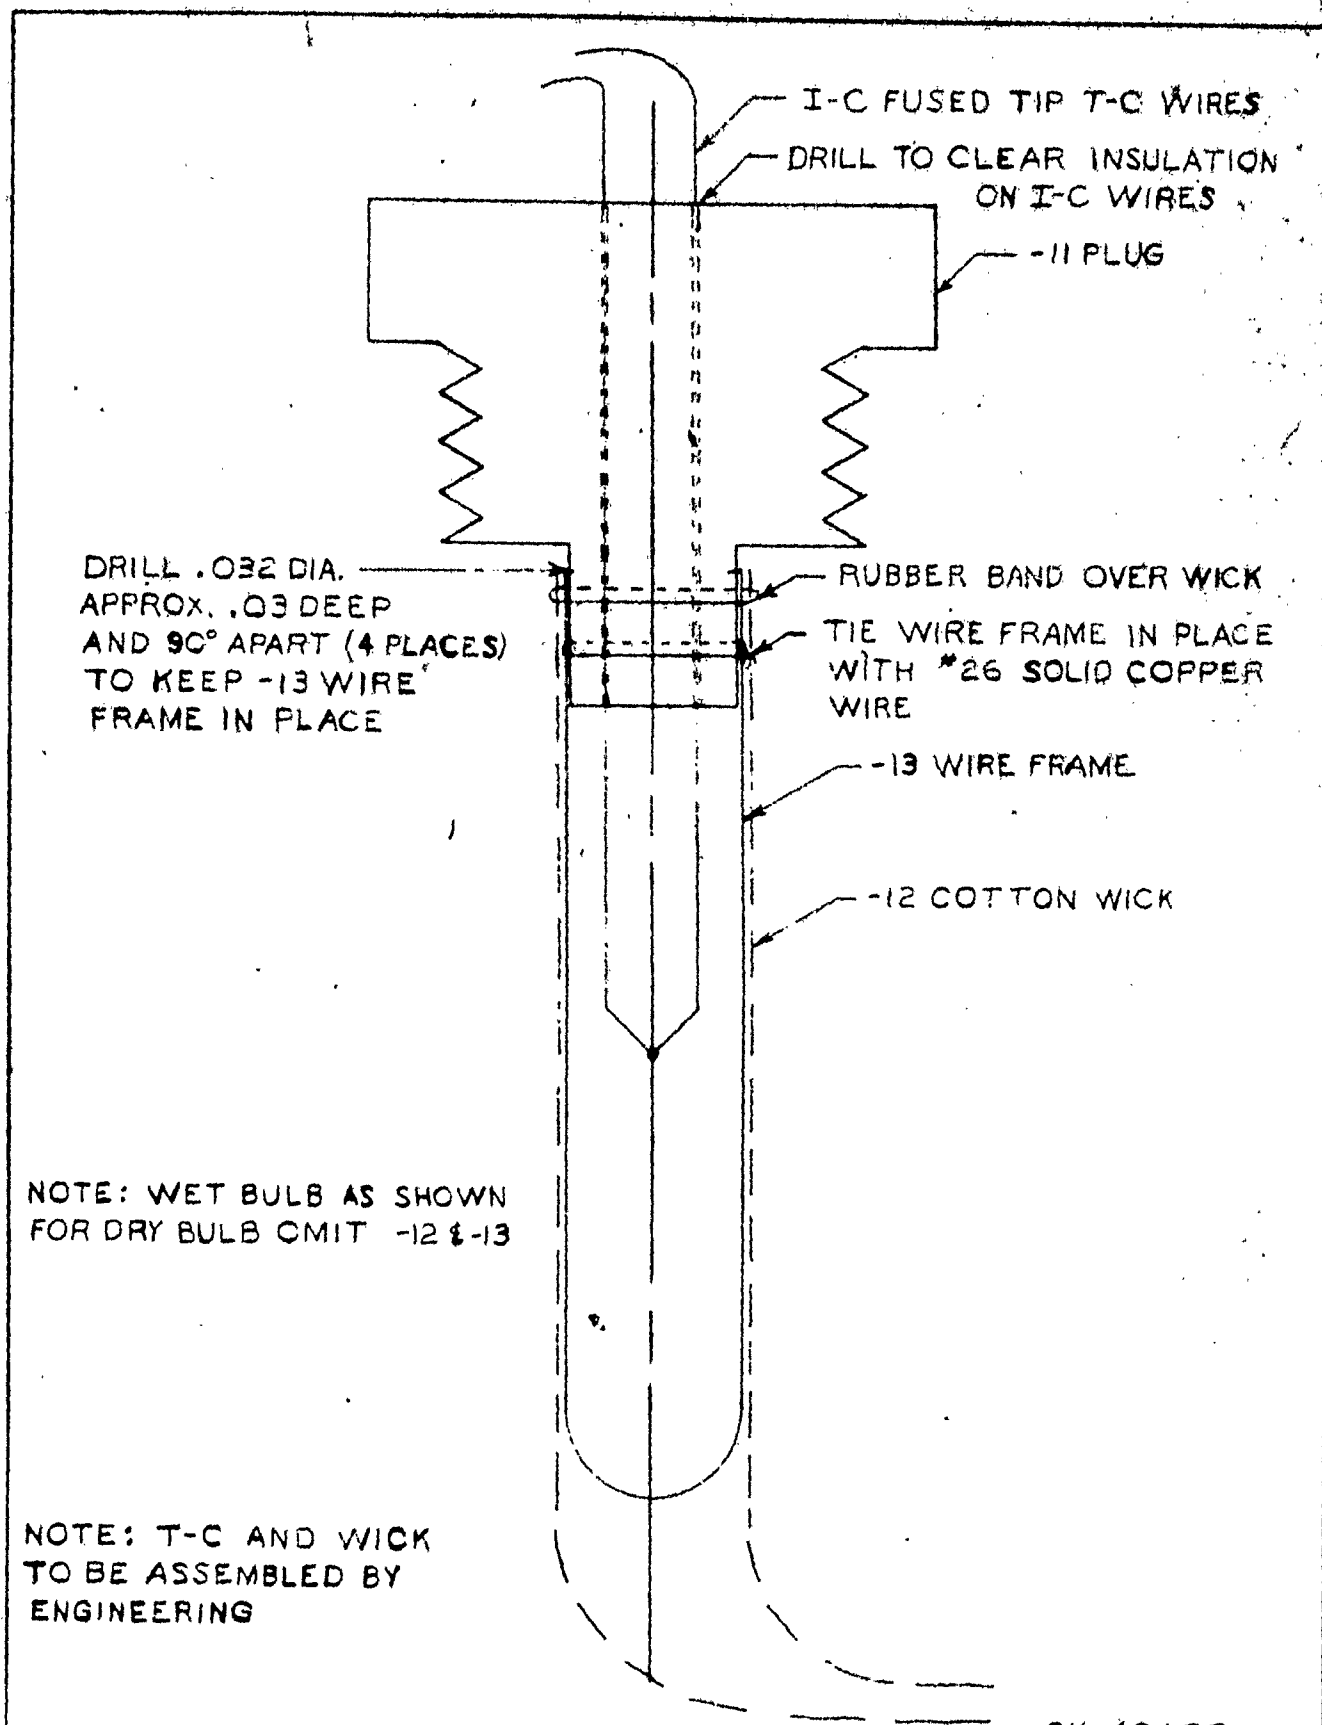
SK-40465

CALC	JMc	8/12/53	REVISED	DATE	PICKUP ASSEMBLY WET AND DRY BULB TEMPERATURE	GEN.
CHECK	JMc	8/2/53				WD
APP	JMc	9/14/53				12829
APP						150-7
CONTRACT NO.					Insert No. 3 WD-14018 Page 166

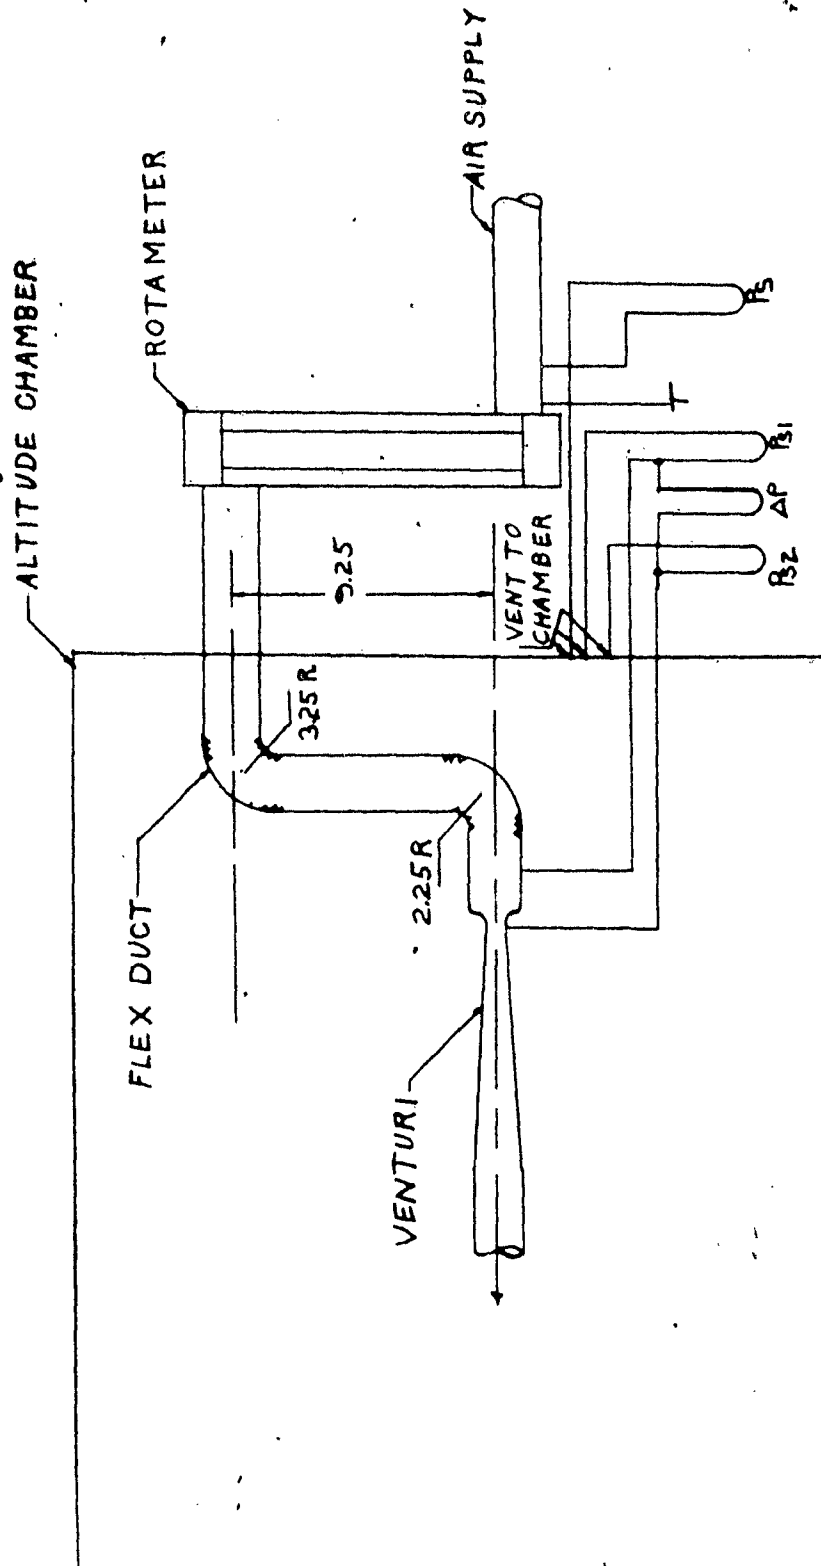
CALC	M. PECHT	3-14-59	REVISED	DATE	<b>VENTURI TEST SETUP</b>  <b>BOEING AIRPLANE CO.</b> WICHITA DIVISION      WICHITA 1, KANSAS	FIGURE 1
CHECK	<i>[Signature]</i>	7-9-59				RB47E
APR						M-1307
APR						PAGE 8
CONTRACT NO.					Insert No. 4 WD-14018 Page 176

SCHEMATIC OF 6-44294  
VENTURI CALIBRATION

The above equipment was set up as shown in Figure 1. The ducts immediately preceding the venturi were used to simulate airplane configuration in order to obtain airflows similar to those obtained in the actual airplane installation.

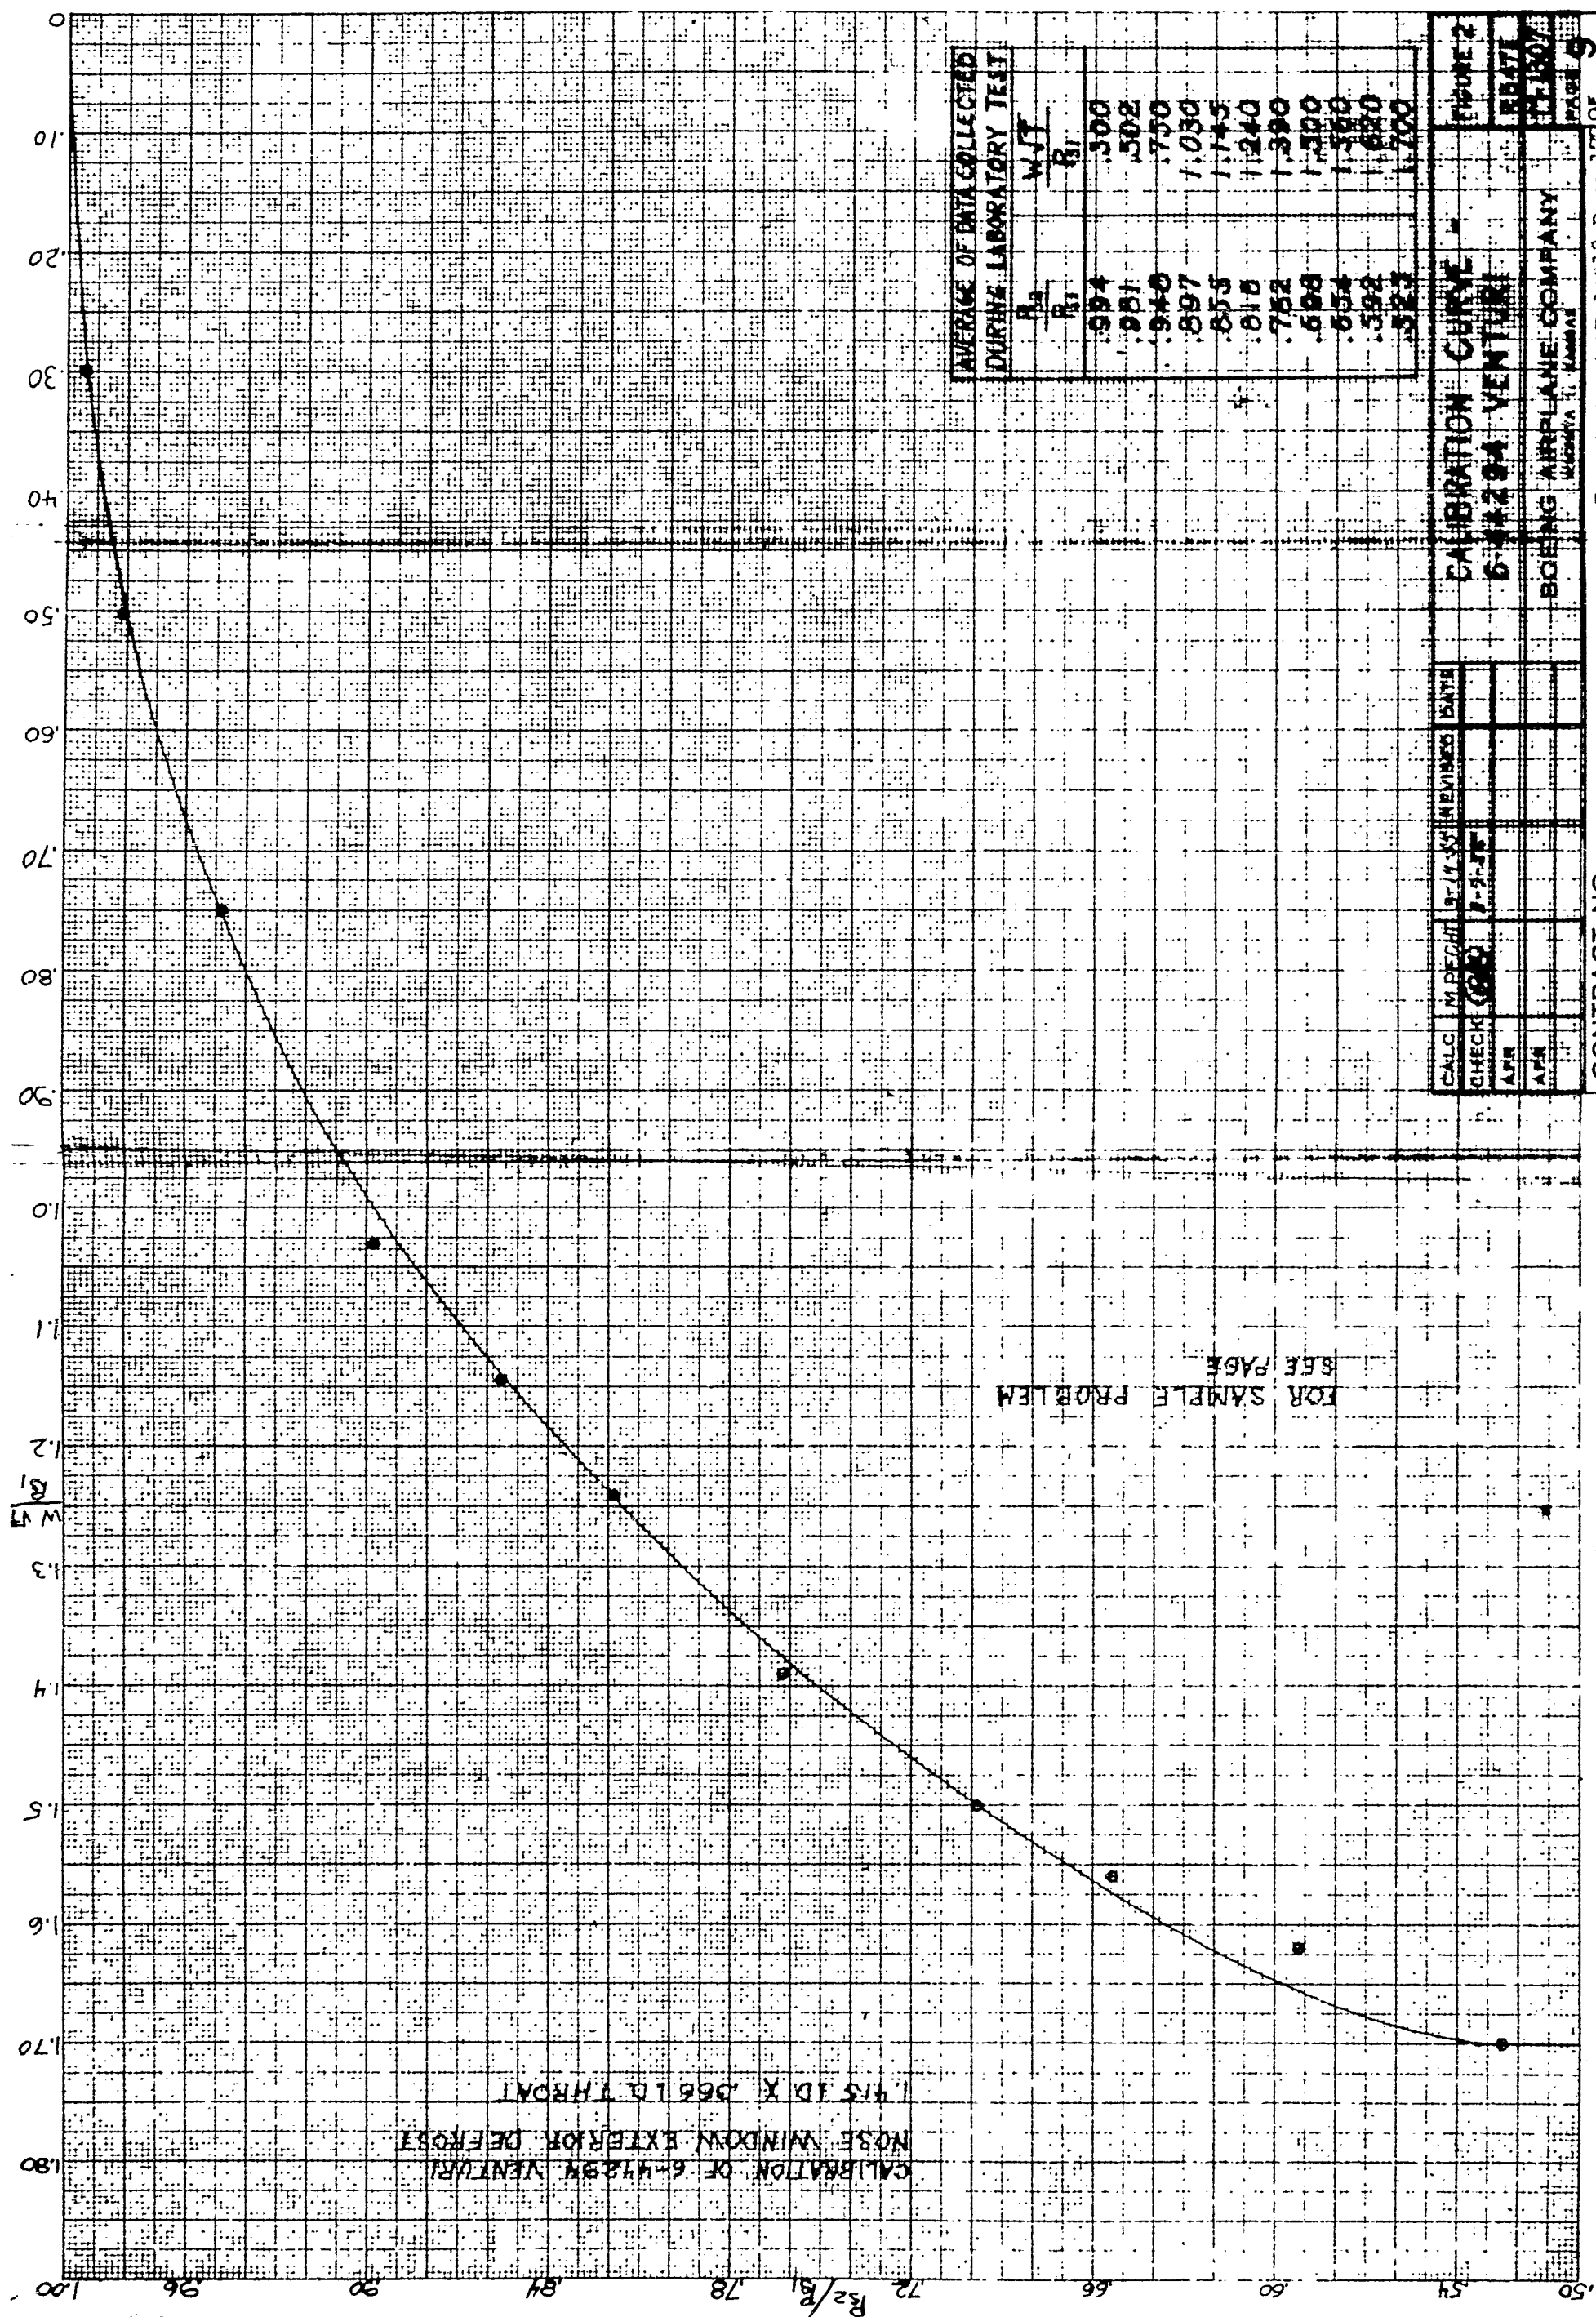
CALIBRATION OF 6-44294 VENTURI  
NOSE WINDOW EXTERIOR DEFROST  
1.415 ID X .066 ID THROAT

It is concluded as a result of this test that the data collected makes a curve which is suitable for use in determining the air flow performance of the RB-47E nose window exterior defrost system during flight test WFT 709. (Reference 3). The theoretical flow through a venturi when plotted forms a parabolic curve like the one shown by Figure 2, confirming the validity of the data.
